PETRONAS Water Technology Users Forum 2003

Non-Chemical Scale Control of Water Process Systems

**Presented at the Petronas Water Technology Users Forum 2003
11 – 12 March 2003, MS Garden Hotel, Kuantan, Malaysia**

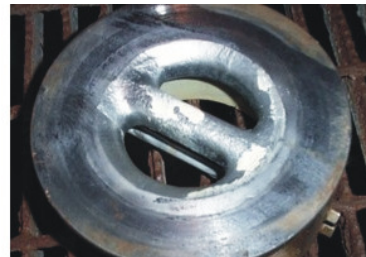
Non-Return Valve

No Scale Build Up After 8 Months With MFC's Installed

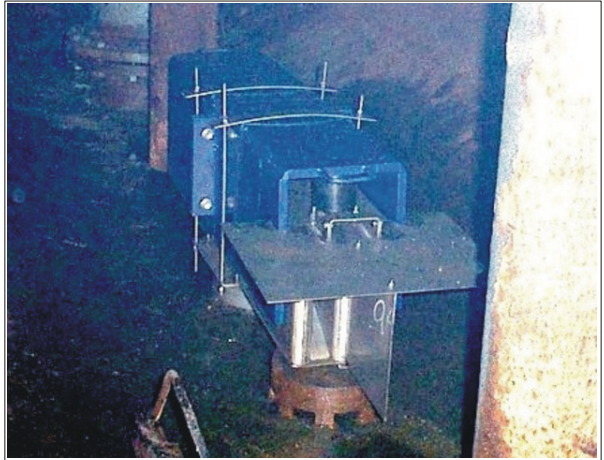
Appendix D

Scale-X™ MFC Installed on the Separation Vessel Water Outlet Standpipe

Specially designed "application specific" Scale-X™ MFC's were installed internal to the separation vessel on the standpipes and replaced the vortex breakers. These MFC's incorporated vortex breaker duties and a photograph of the MFC on the water outlet standpipe is shown in Appendix D.

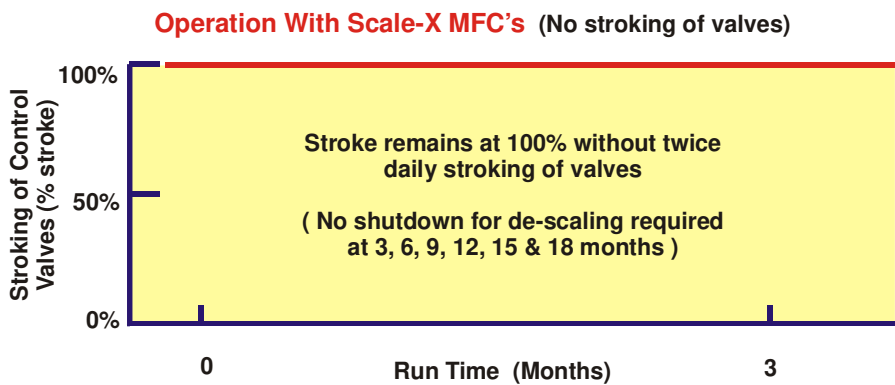
Appendix E

Stroking of Flow Control Valves
Oil & Water Separation Vessel Control Valves
Without and With Scale-X MFC's

Appendix C photographs show the scale build ups after 3 months without the MFC's and no scale build-up at 8 months with the MFC's installed. (The photographs at 8 months were taken during the general field shutdown.) Appendices E and F show the stabilised operational performance of the platform system in maintaining full production output with the control valves remaining fully operational.

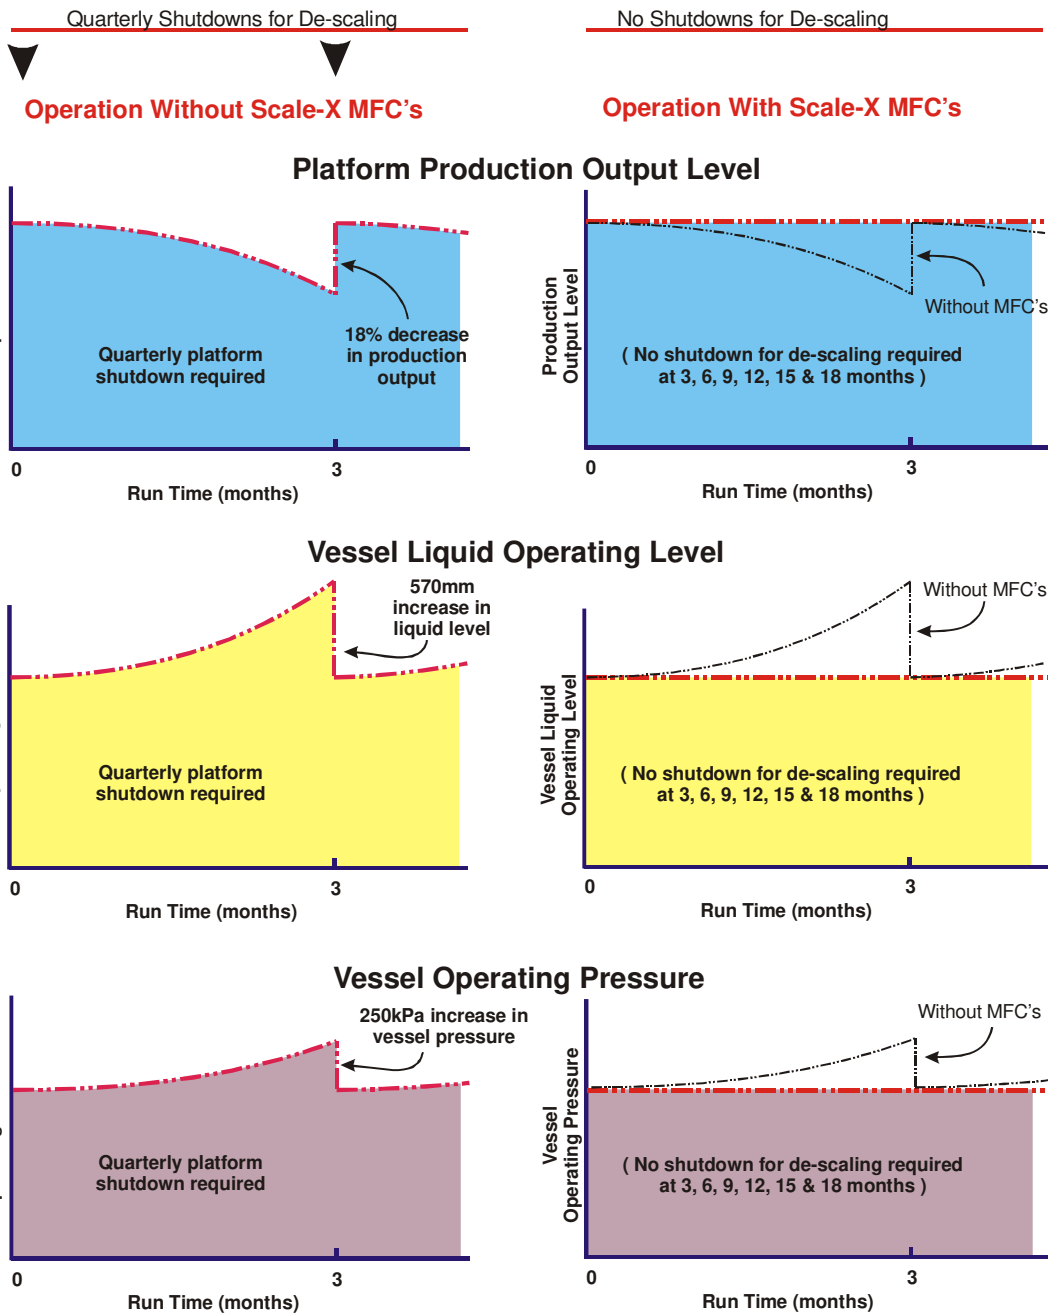
Appendix F

Platform Operational Parameters
Production Output, Vessel Liquid Level & Vessel Pressure
South China Sea, Tinggi Field Offshore Oil Platform
Without and With Scale-X MFC's
